HABITAT SURVEY REPORT

ENVIRONMENTAL IMPACT STATEMENT

Bremerton Waterfront Infrastructure Improvements

Naval Base Kitsap Bremerton, Washington

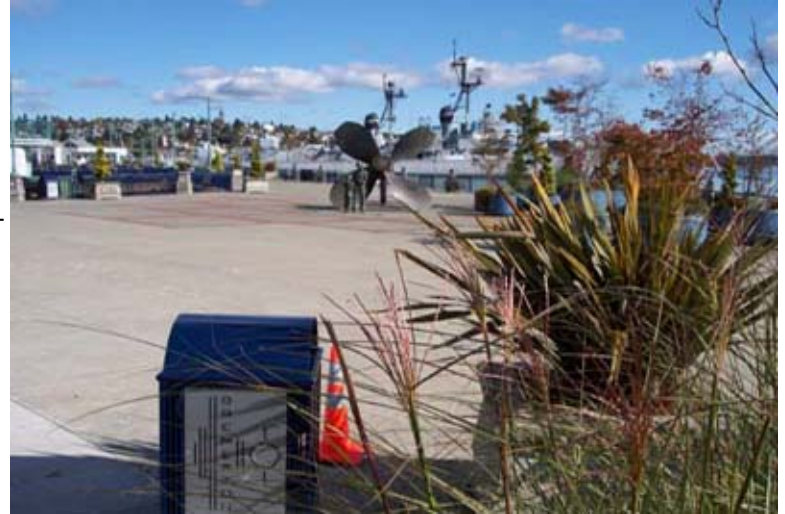
Survey Control

THE STATION IS AT THE WASHINGTON STATE FERRY TERMINAL IN BREMERTON. IT IS LOCATED APPROXIMATELY 85 METERS NORTH OF 1ST STREET ALONG THE BREMERTON BOARDWALK AND NEAR THE WESTERLY EDGE OF THE CONCRETE WALKWAY, IN LINE WITH THE NORTHERLY PIER OF THE MARINA, BETWEEN THE MARINA SUPPORT FACILITY BUILDING AND THE SEWAGE PUMP STATION/RESTROOM BUILDING, 24.4 METERS @ 200 DEGREES FROM A BRONZE PROPELLER STATUE, 12.1 METERS @ 305 DEGREES FROM THE NORTHWEST CORNER OF BUILDING # 102, 16.9 METERS @ 25 DEGREES FROM THE PORT OF BREMERTON MARINA SUPPORT FACILITY AND 11.1 METERS @ 125 DEGREES FROM A FLAG POLE IN RECOGNITION OF THE PUGET SOUND NAVAL SHIP YARD. THE MARK IS A WSDOT BRASS DISK CEMENTED INTO A DRILL HOLE AND SET LEVEL WITH THE CONCRETE SURFACE.

*NOTE: THIS STATION SIGHTS GP18304-21.
*NOTE: THIS MARK IS SET ON A WOODEN-PILE STRUCTURE.

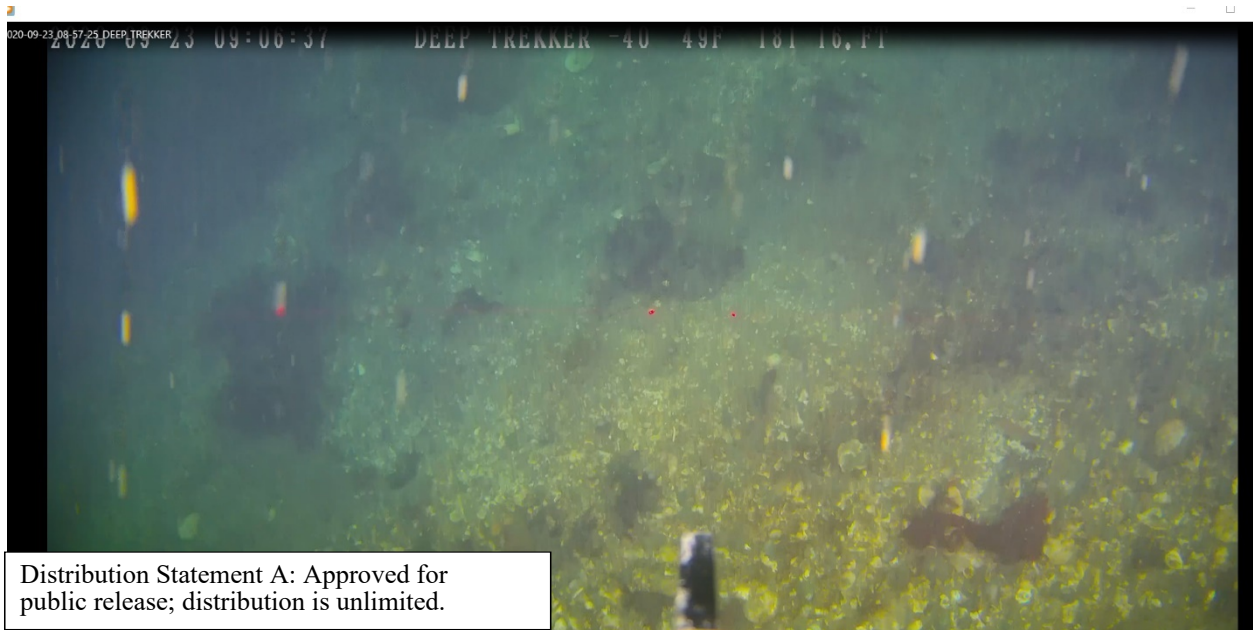
Low Density:

Tide Corrected Depth: -43 feet (-13 meters) Coordinates (UTM): 1194581.27397 E, 208481.823429 N

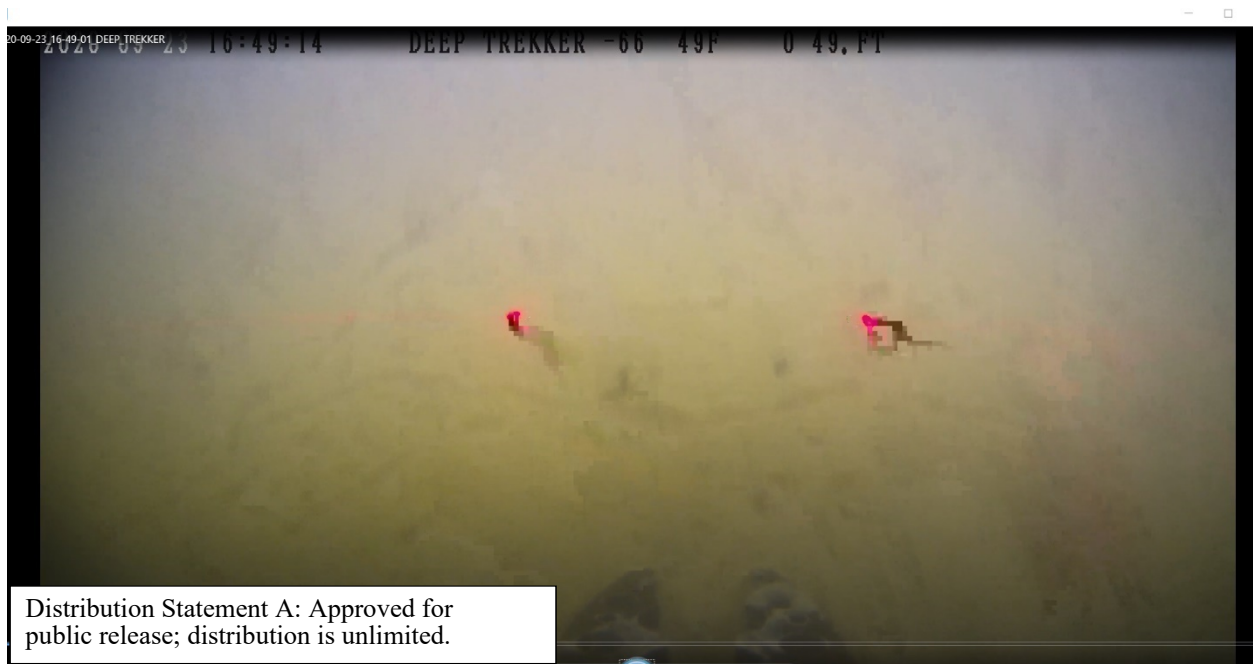
None:

Tide Corrected Depth: -42 feet (-13 meters)

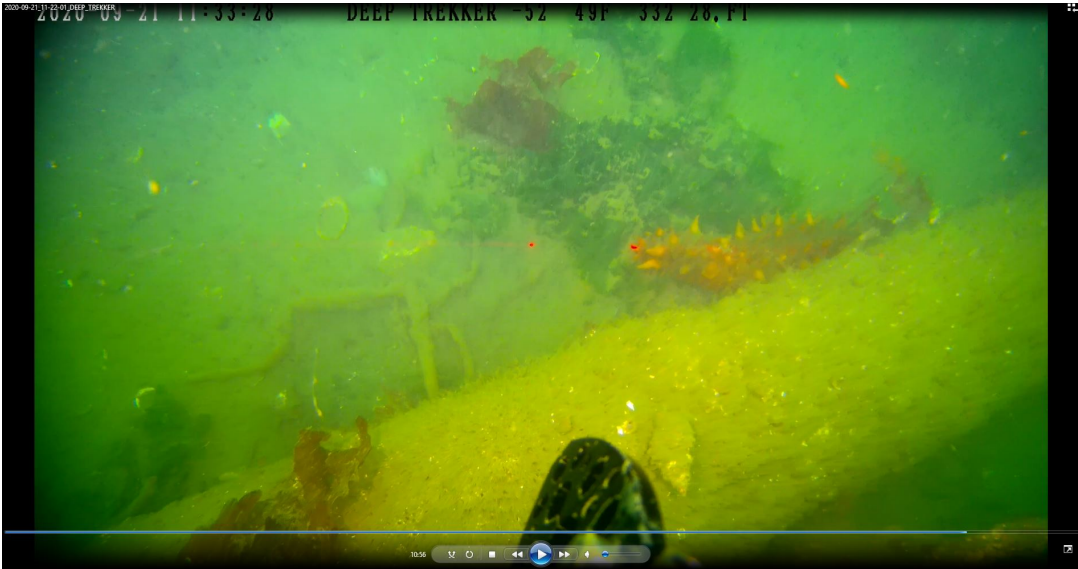
| Photo No. 1 | Date: 9/21/20 | <div style="border: 1px solid black; padding: 5px;"> Distribution Statement A: Approved for public release; distribution is unlimited. </div> | |

| Description: Typical red and green macroalgae, with a sea cucumber next to some underwater debris. Near shoreline between Pier D and Mooring E. Tide Corrected Depth: -39 feet (-12 meters) Coordinates (UTM): 1191426.22475 E 208045.185383 N | | | |

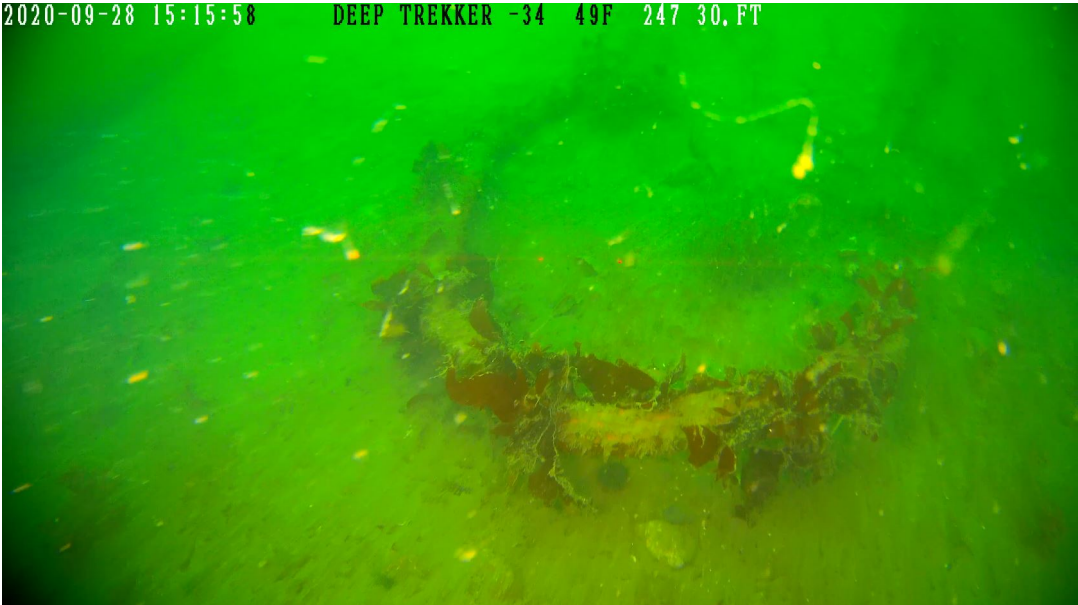
| Photo No. 2 | Date: 9/28/20 | <div style="border: 1px solid black; padding: 5px;"> Distribution Statement A: Approved for public release; distribution is unlimited. </div> | |

| Description: Typical macroalgae growing on a cable, east of Pier 7. Tide Corrected Depth: -10 feet (-3 meters) Coordinates (UTM): 1197446.86299 E 209401.082414 N | | | |

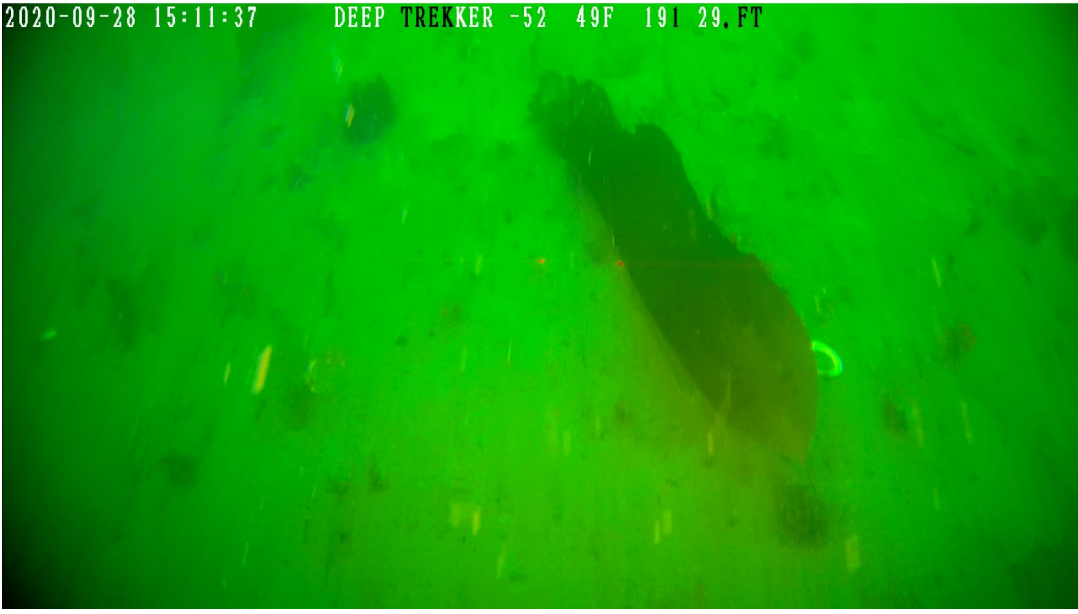
| Photo No. 3 | Date: 9/28/20 | Distribution Statement A: Approved for public release; distribution is unlimited. | |

As mentioned in Section 3.4.2, one incidence of kelp was observed. Photo 3 in Appendix F seems to indicate five-ribbed kelp (*Costaria costata*) or broad-rib kelp (*Pleurophycus garneri*) (Druehl 2000).

| Description: Kelp, east of Pier 7. Tide Corrected Depth: -10 feet (-3 meters) Coordinates (UTM): 1197560.40216 E 209466.80845 N | | | |

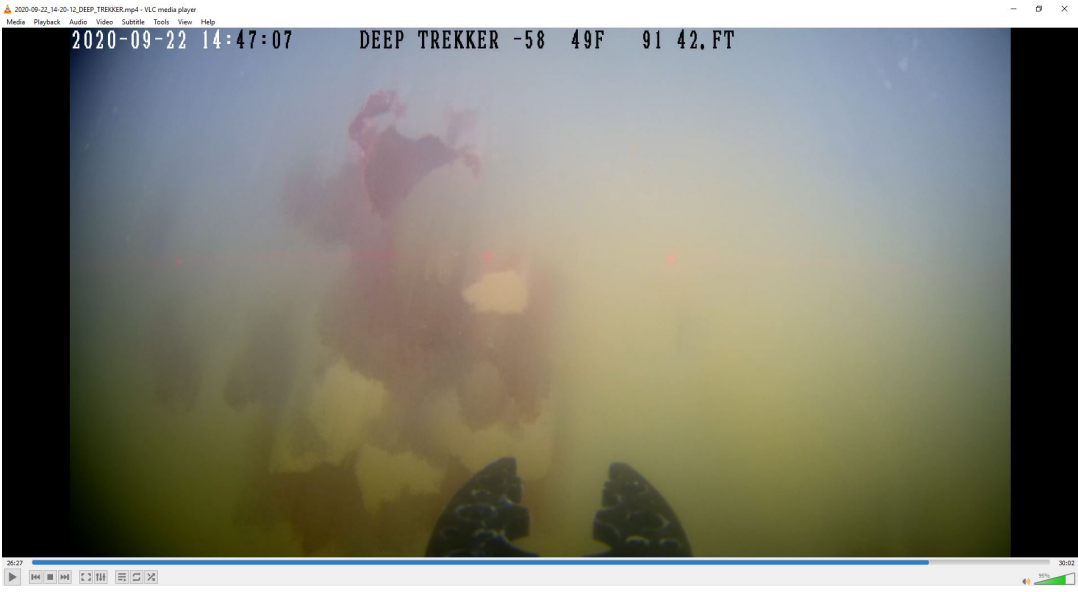
| Photo No. 4 | Date: 9/22/20 | <div style="border: 1px solid black; padding: 5px;"> Distribution Statement A: Approved for public release; distribution is unlimited. </div> | |

| Description: Typical macroalgae, near ROV-14. Tide Corrected Depth: -46 feet (-14 meters) Coordinates (UTM): 1194482.3867599 E 204178.816831 N | | | |

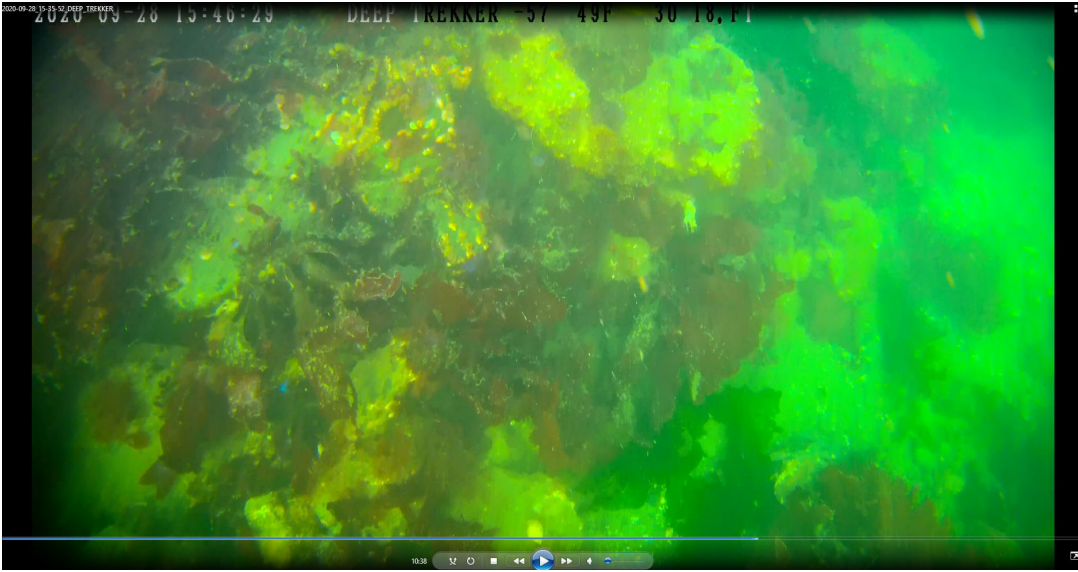
| Photo No. 5 | Date: 9/28/20 | <div style="border: 1px solid black; padding: 5px;"> Distribution Statement A: Approved for public release; distribution is unlimited. </div> | |

| Description: Typical macroalgae east of Pier 7. Tide Corrected Depth: -35 feet (-11 meters) Coordinates (UTM): 1197581.93346 E 209569.976468 N | | | |

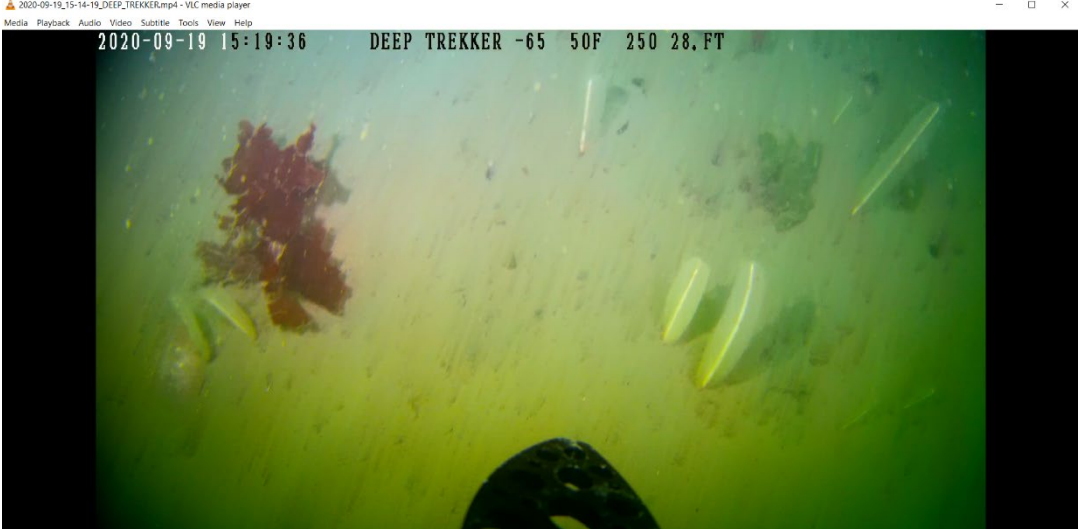
| Photo No. 6 | Date: 9/19/20 | <div style="border: 1px solid black; padding: 5px;"> Distribution Statement A: Approved for public release; distribution is unlimited. </div> | |

| Description: Typical macroalgae on the south side of Sinclair Inlet Tide Corrected Depth: -50 feet (-15 feet) Coordinates (UTM): 1197900.65909 E 205399.686363 N | | | |

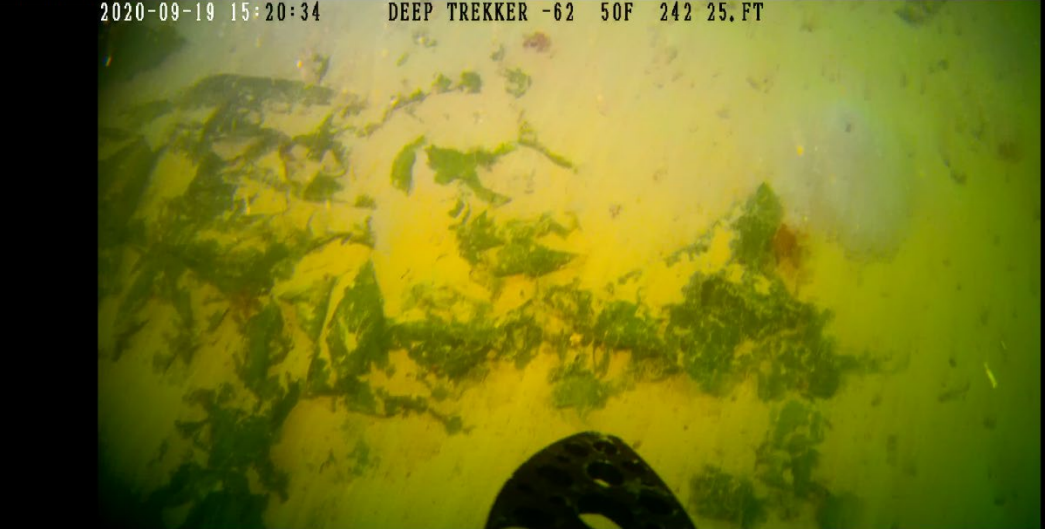
| Photo No. 7 | Date: 9/19/20 | <div style="border: 1px solid black; padding: 5px;"> Distribution Statement A: Approved for public release; distribution is unlimited. </div> | |

| Description: Typical macroalgae on the south side of Sinclair Inlet Tide Corrected Depth: -51 feet (-16 feet) Coordinates (UTM): 1197888.63091 E 205395.683636 N | | <div style="border: 1px solid black; padding: 5px;"> <p style="font-size: small; margin: 0;">2020-09-19_15-14-19_DEEP_TREKKER.mp4 - VLC media player</p> <p style="font-size: x-small; margin: 0;">Media Playback Audio Video Subtitle Tools View Help</p> <p style="font-size: small; margin: 0;">2020-09-19 15:20:34 DEEP TREKKER -62 50F 242 25.FT</p> </div> | |
